FIELD OBSERVATION REPORT A

PROJECT: Dan Foley Park, Vallejo; Synthetic Field Resurfacing

Lloyd Project No.
21-180

Site Visit Date & Time: Wednesday August 3, 2022, 8am

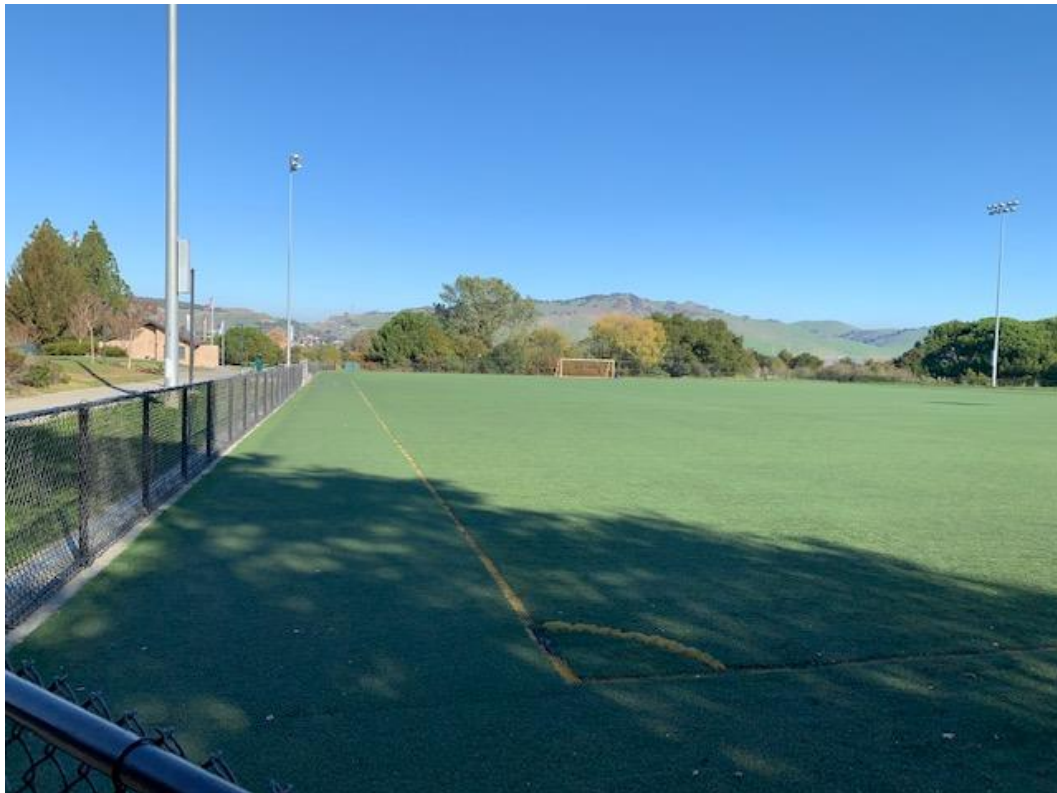
Photo 1 – Overview

1. The site was dry with no standing water on the field or adjacent landscapes.
2. The synthetic turf is at or very near the end its useful life with several obvious patches in high wear areas and a few minor spots where the turf has worn through to the backing and beyond.

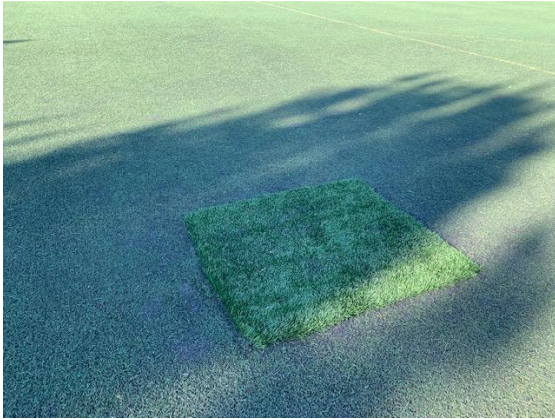
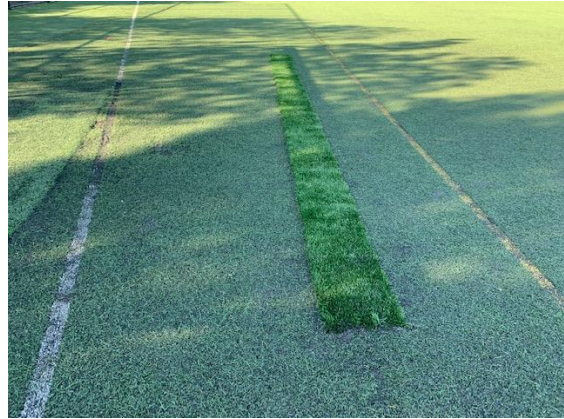
Photo 2 & 3 – Localized patches

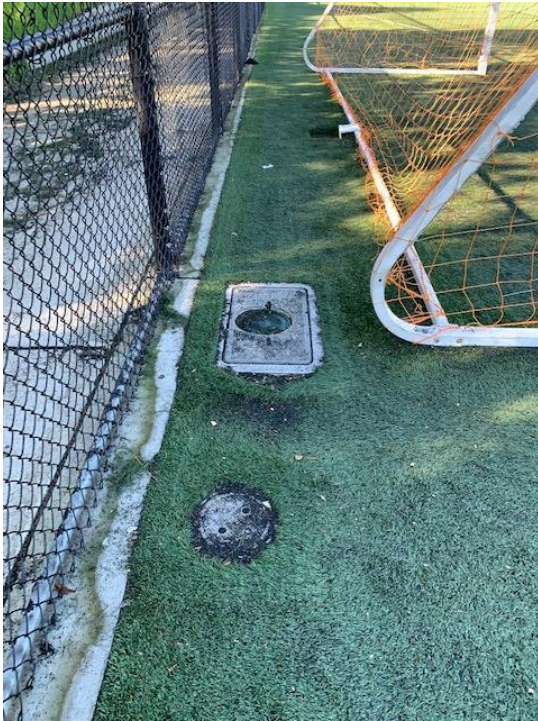
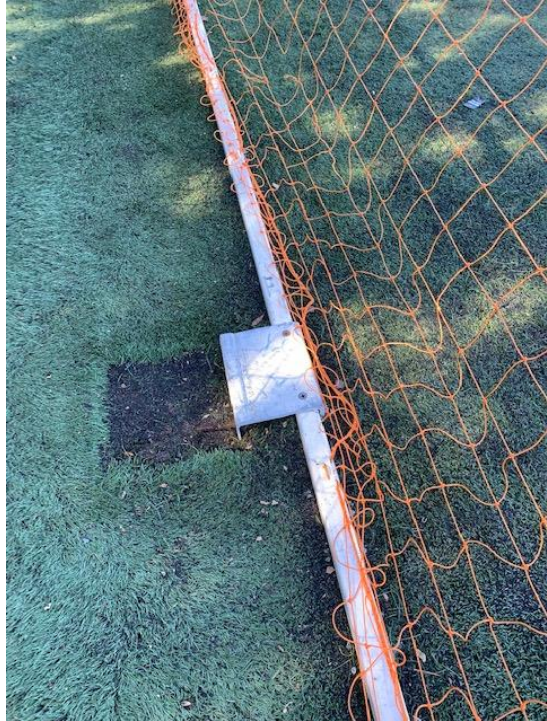
7. All of the surface utility features and boxes were reviewed, and some adjustments and local repairs will be needed, particularly around the in-ground water cannon irrigation systems should they be retained as part of the project.

Photo #4 & #5 – In-ground Utilities

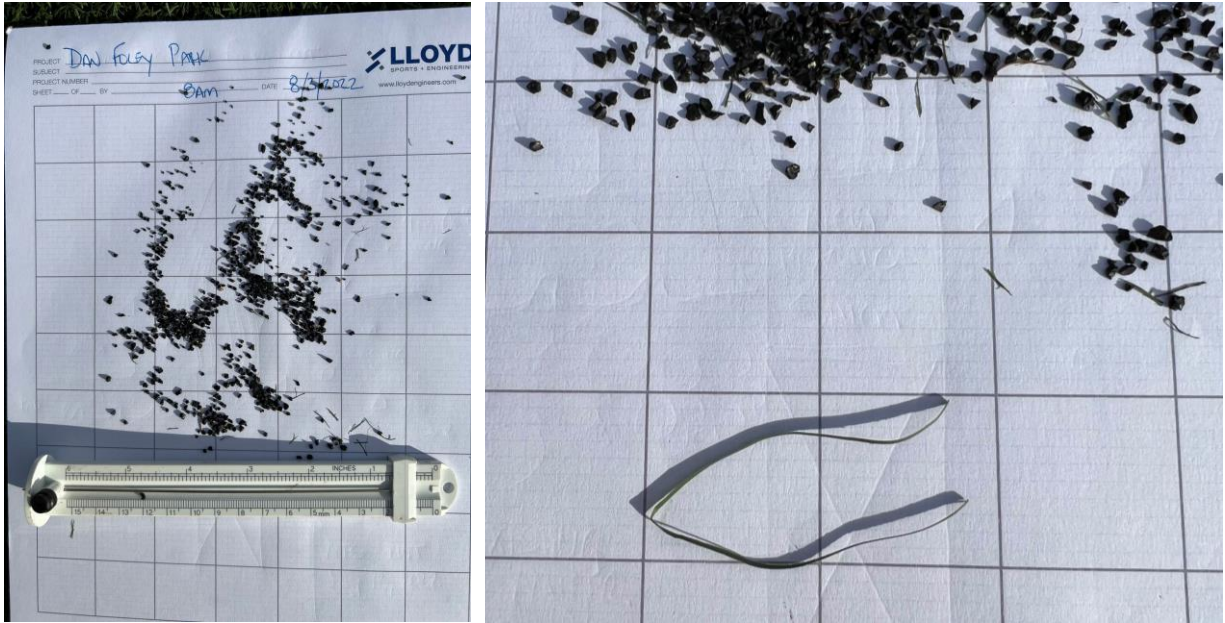
- Lloyd gathered some samples of the existing in-fill and fiber. The infill appears to be a blend of clean sand and rubber particles. Based upon the shiny nature of the rubber surfaces and the clean angles it is likely that the materials are a "cryogenic" rubber. The fiber appears to be a 2" pile height all monofilament fiber.

Photo #9 & #10 – Crumb rubber sample and Fiber turfing length

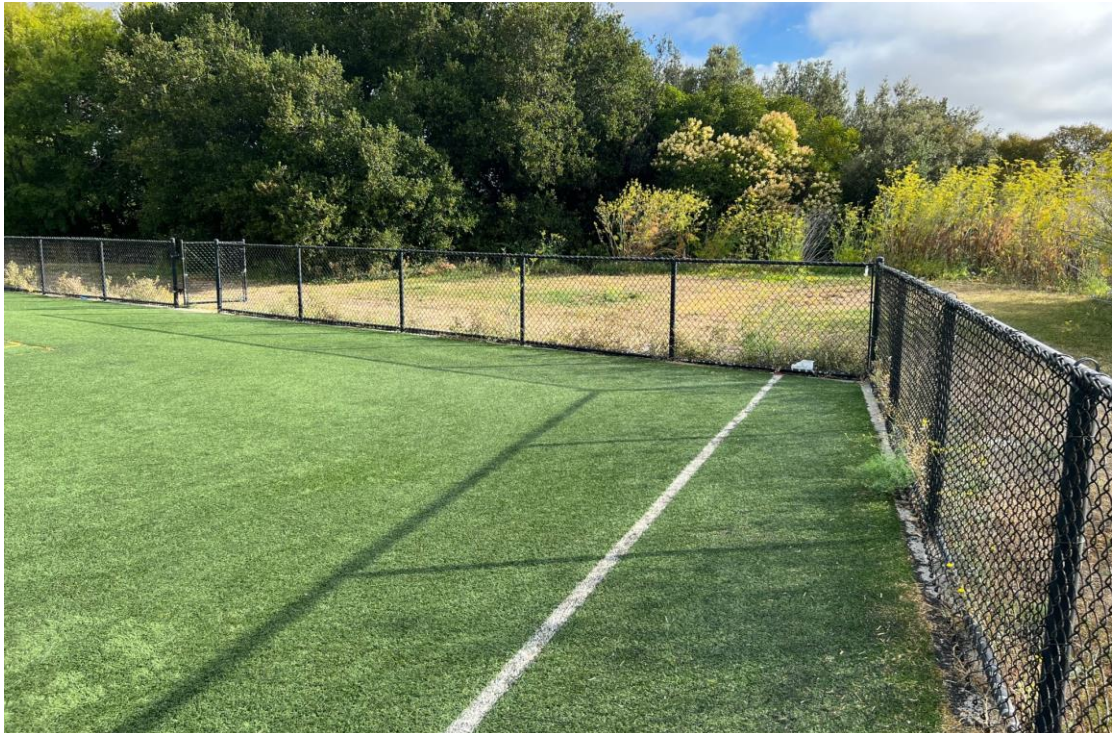
Photo # 11 – Northeast Corner Selected for Investigation

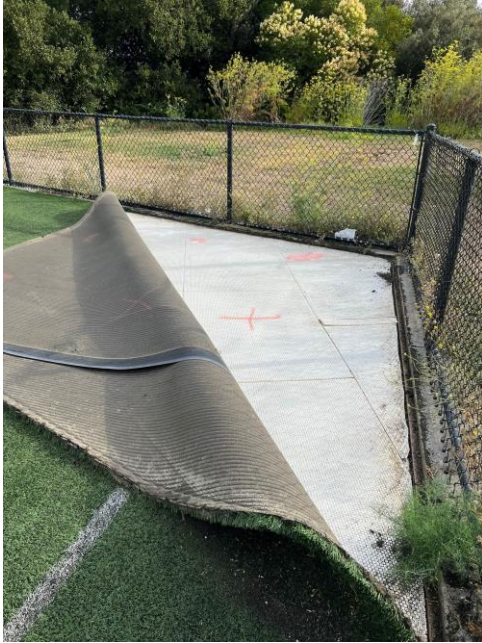
Photo #12 – Underlayment

- The carpet was carefully peeled back exposing the first layer of materials a white foam underlayment (Brock Power Base?). This material provides both shock attenuation for user safety and horizontal drainage just under the playing surface. The back of the turf was in good condition and indicated a FieldTurf product based on the manufacturing technique and wider tuft gauge.

13. The underlayment is in fair condition and should withstand a resurfacing with only minor patch and repair after demolition of the turf. The product typical has a 20 - 25 year warranty.

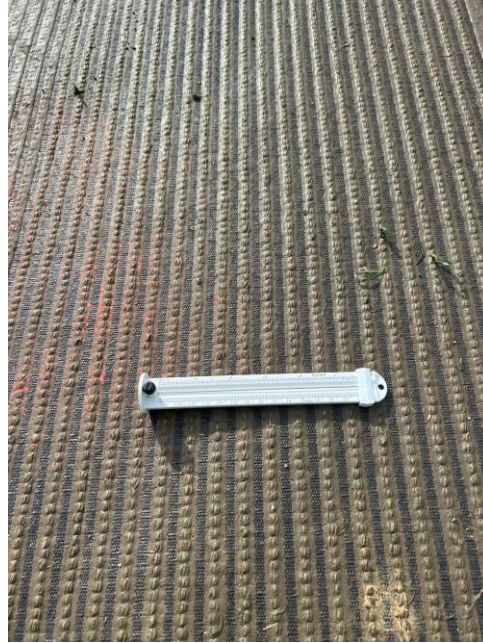
Photo # 11- Turf backing

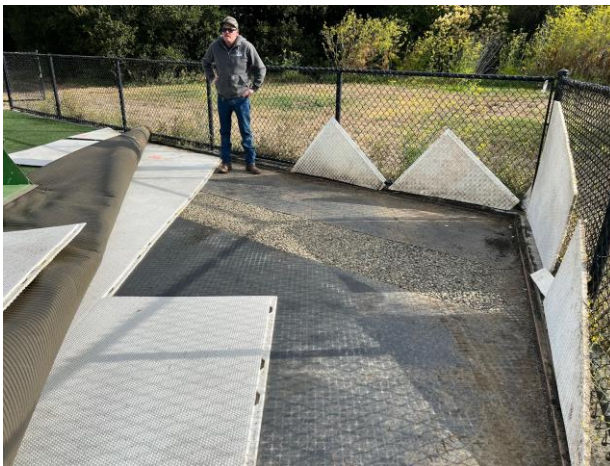
- The underlayment was removed and revealed a base covered in a geofabric and an open stone infiltration drain trench filled with clean angular $\frac{3}{4}$ " stone. The assembly was very clean and no obvious signs of settlement, or lateral movement of silt, sands, or soils. The 30" to 36" wide infiltration trench was in good condition. Upon rolling back the geofabric it revealed a second fabric that lined/wrapped the infiltration trench.

Photo #12 Geofabric and Drain Trench

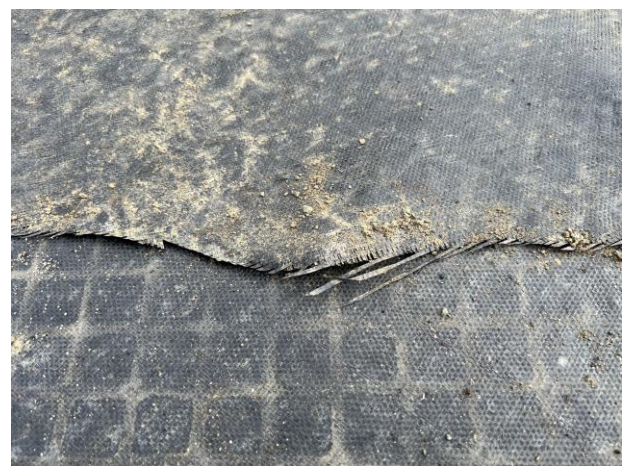
Photo # 13 – Geofabric Close-up

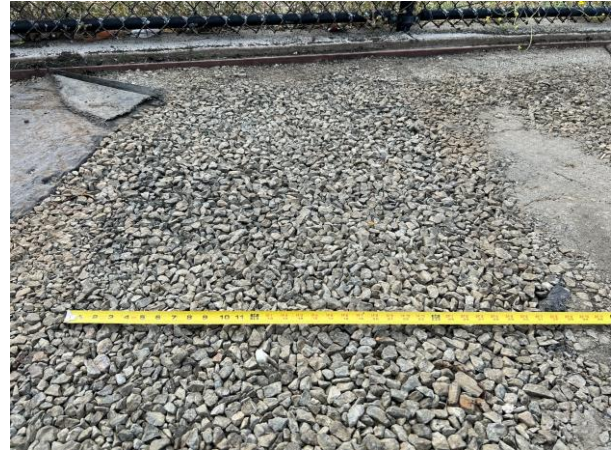
Photo #15 – Infiltration Trench

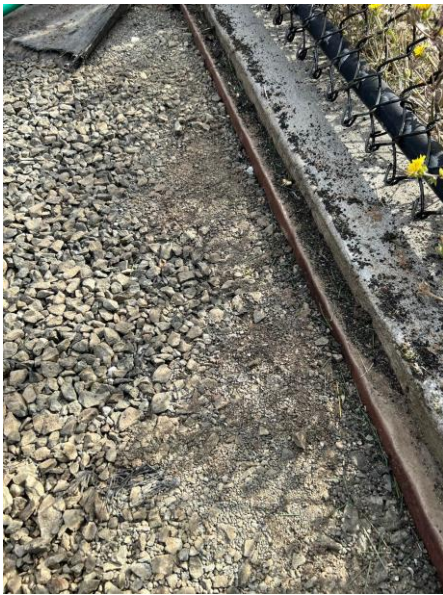
12. The perimeter nailer made of plastic/synthetic lumber was in serviceable condition and well anchored to the concrete perimeter band.

Photo #14 – Nailer

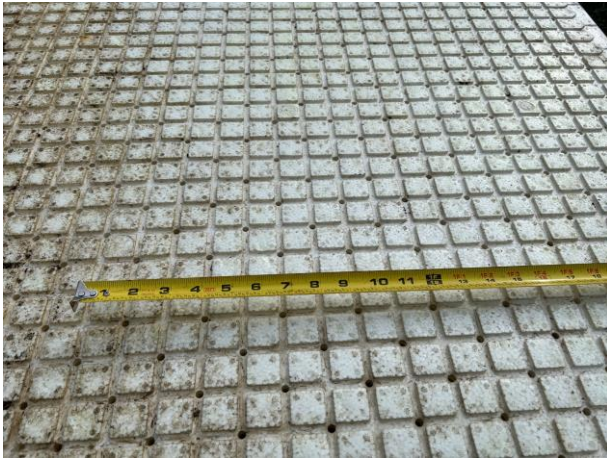
Photo #14 – Bottom side of Underlayment

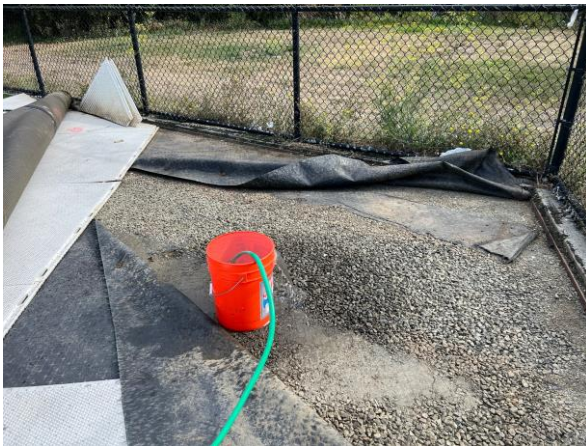
14. An unconfined infiltration test was conducted on the base at the rolled back flap located in the Northeast corner of the field. (ASTM F2898-11 test method was used). The **test was formally inconclusive** as water was moving vertically into the infiltration drain and data could not be collected from this location. A test atop the fabric layer would have likely shed water even quicker to the underground drain system.

Photo 13 – Start of Test on

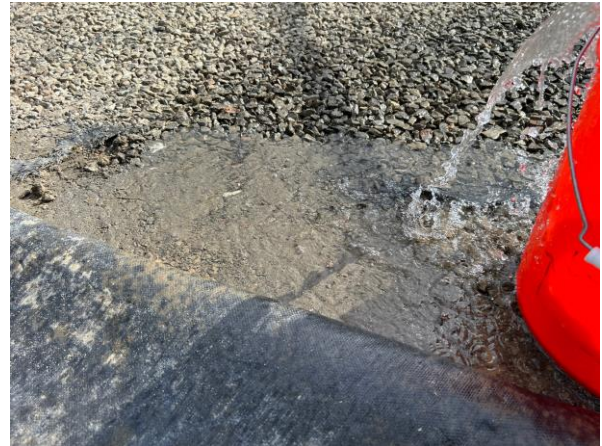
Photo 14 – Water Immediately draining
