# **AMERICAN COMPLIANCE SERVICES, LTD**

**ASBESTOS and LEAD BASED PAINT SURVEY**  
**Administration Building**  
395 Amador Street  
Vallejo, California

**September 27, 2021**

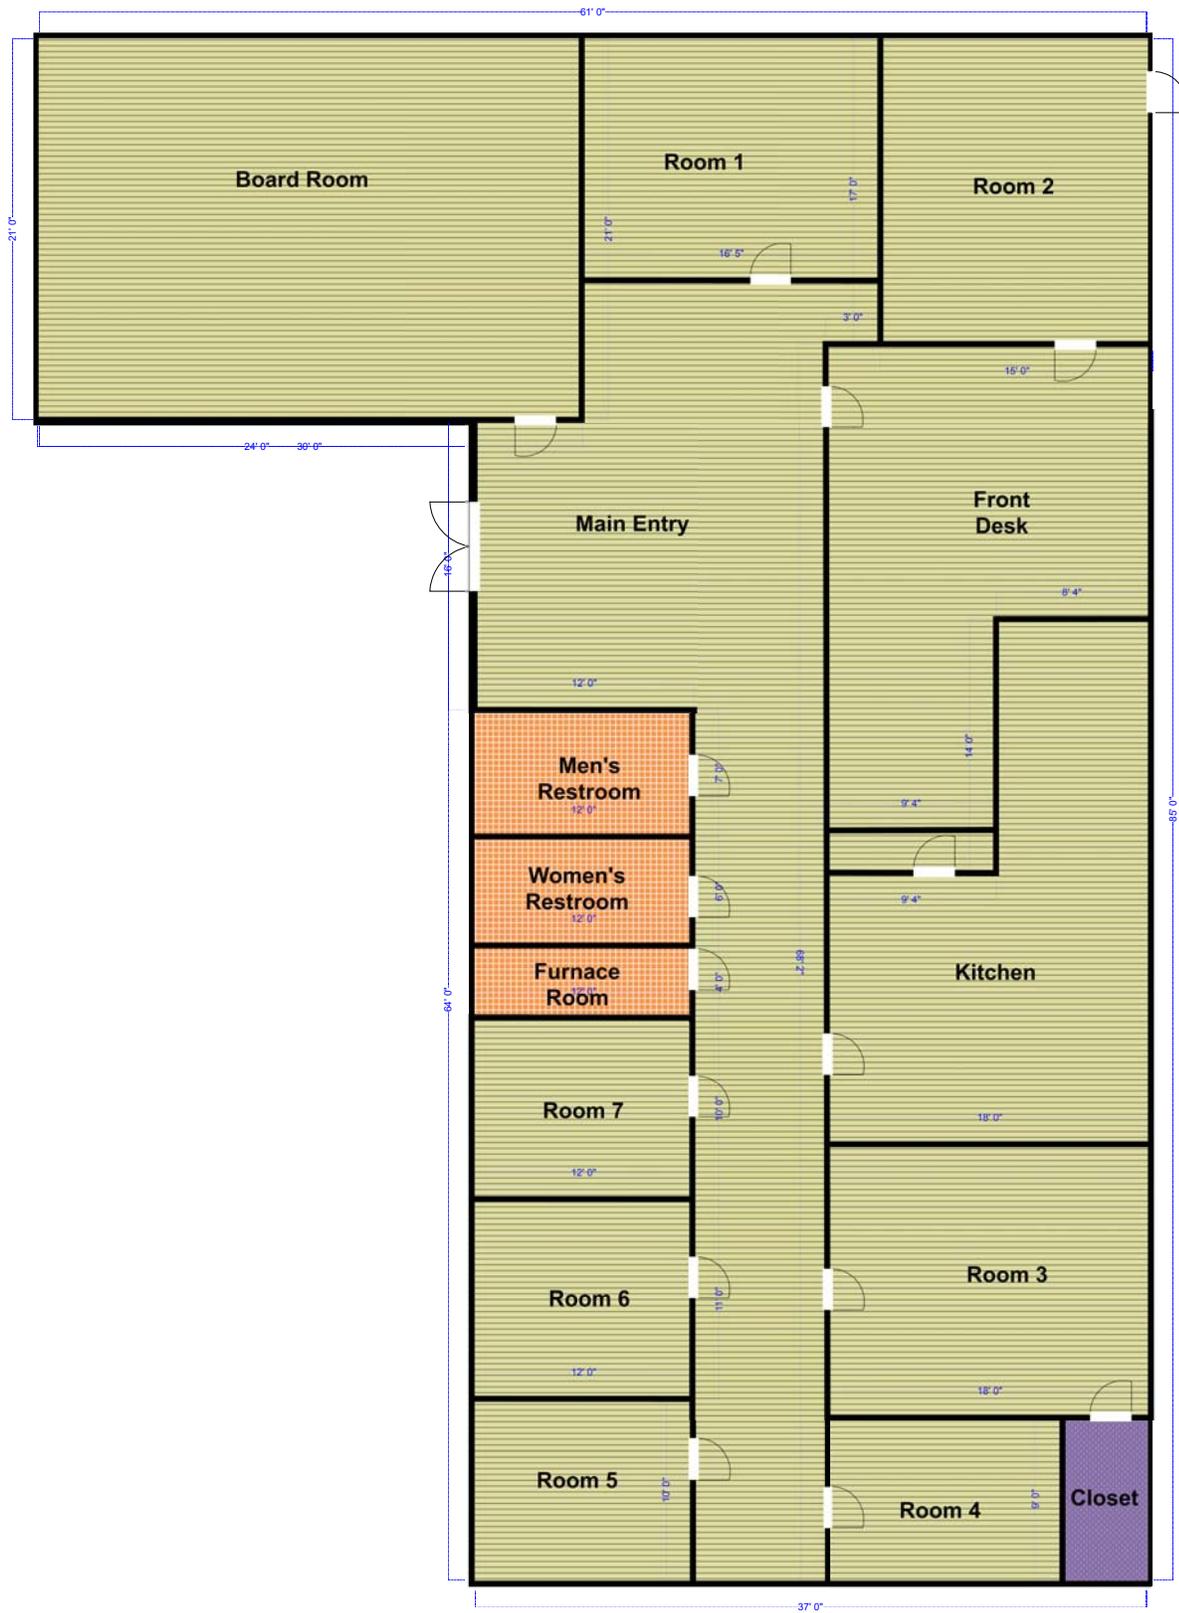
Ceiling Sample Location Maps  
 395 Amador Street  
 Vallejo, Ca

Acoustic Ceiling: 3% CH
-

Plaster: Skim Coat - <1% CH - (<0.25 - 0.50 By Point Count)
-

Drywall System: Joint Compound- 3% CH ( 0.50- 0.75 % CH Drywall and Joint Compound By Point Count)

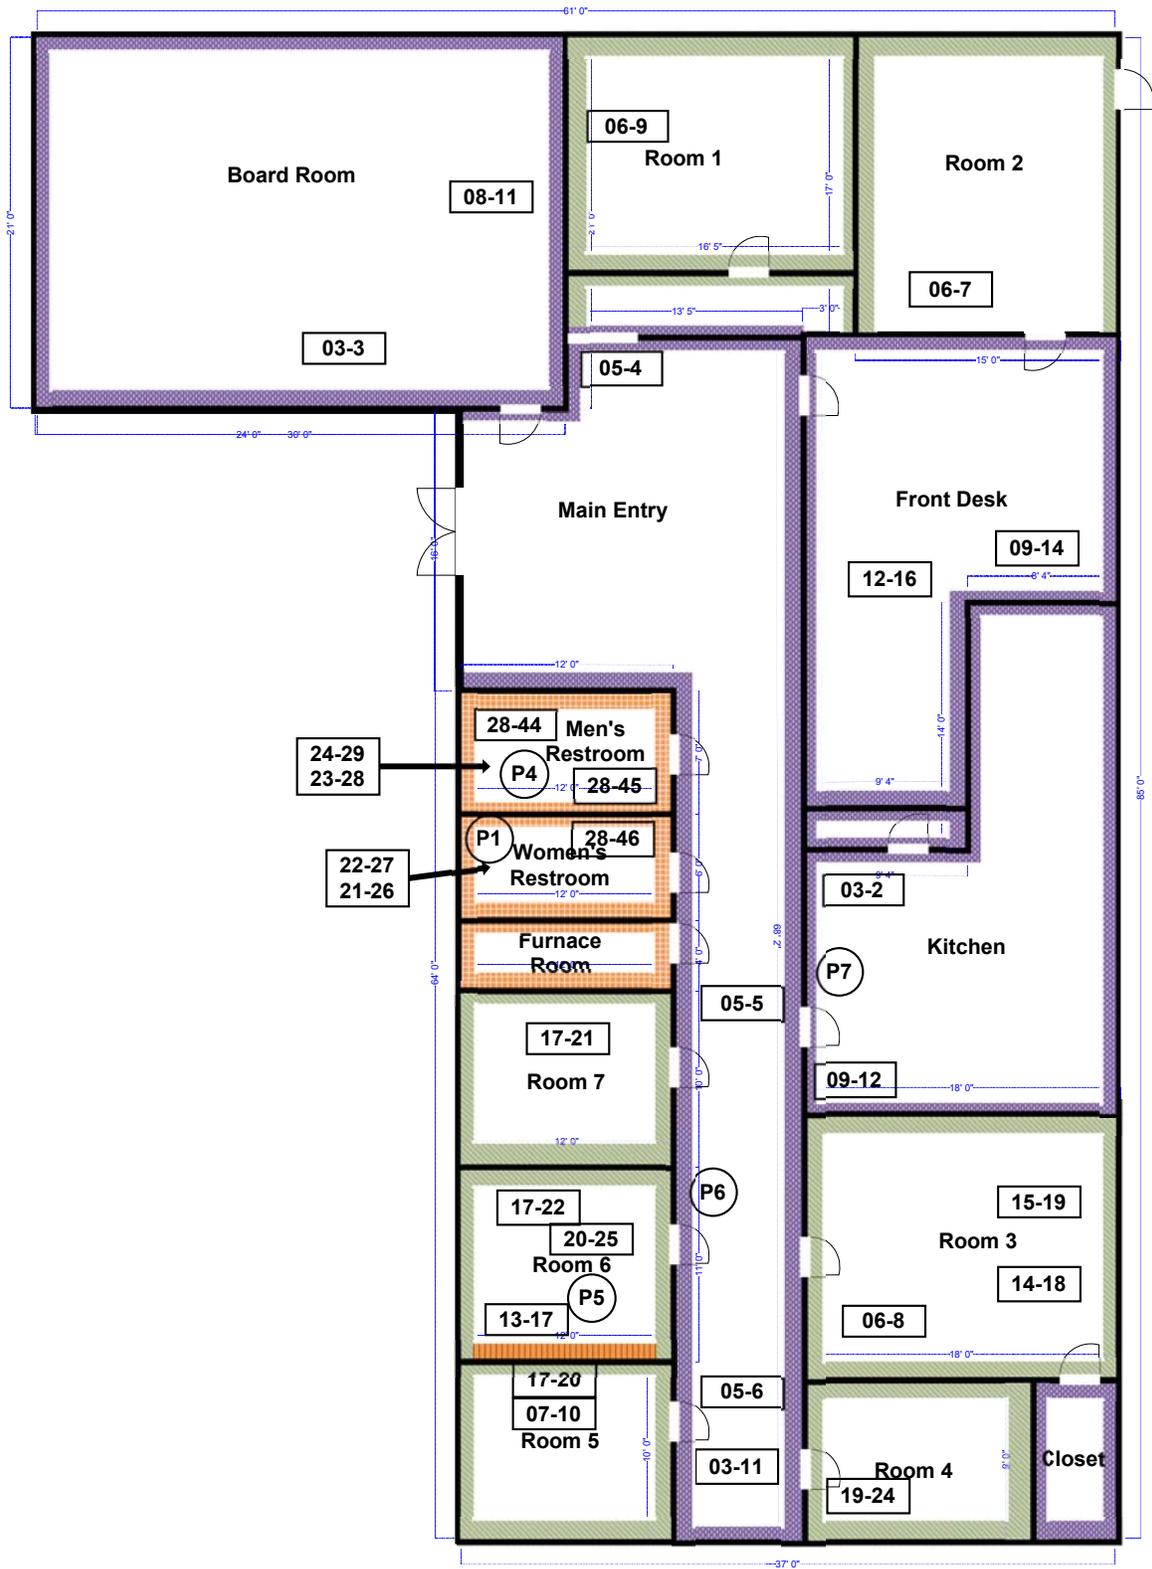
Wall Sample Location Map  
 395 Amador Street  
 Vallejo, Ca

Plaster: Skim Coat - <1% CH <0.25 - 0.50 By Point Count
-

Drywall System: Joint Compound- 3% CH ( 0.50- 0.75 % CH Drywall and Joint Compound By Point Count)
-

Coating over Cork Board (with or without wallpaper) - Coating/ Compound- 2-3% CH
-

Coating on Wood Wall - Compound (Beige)- 3% CH

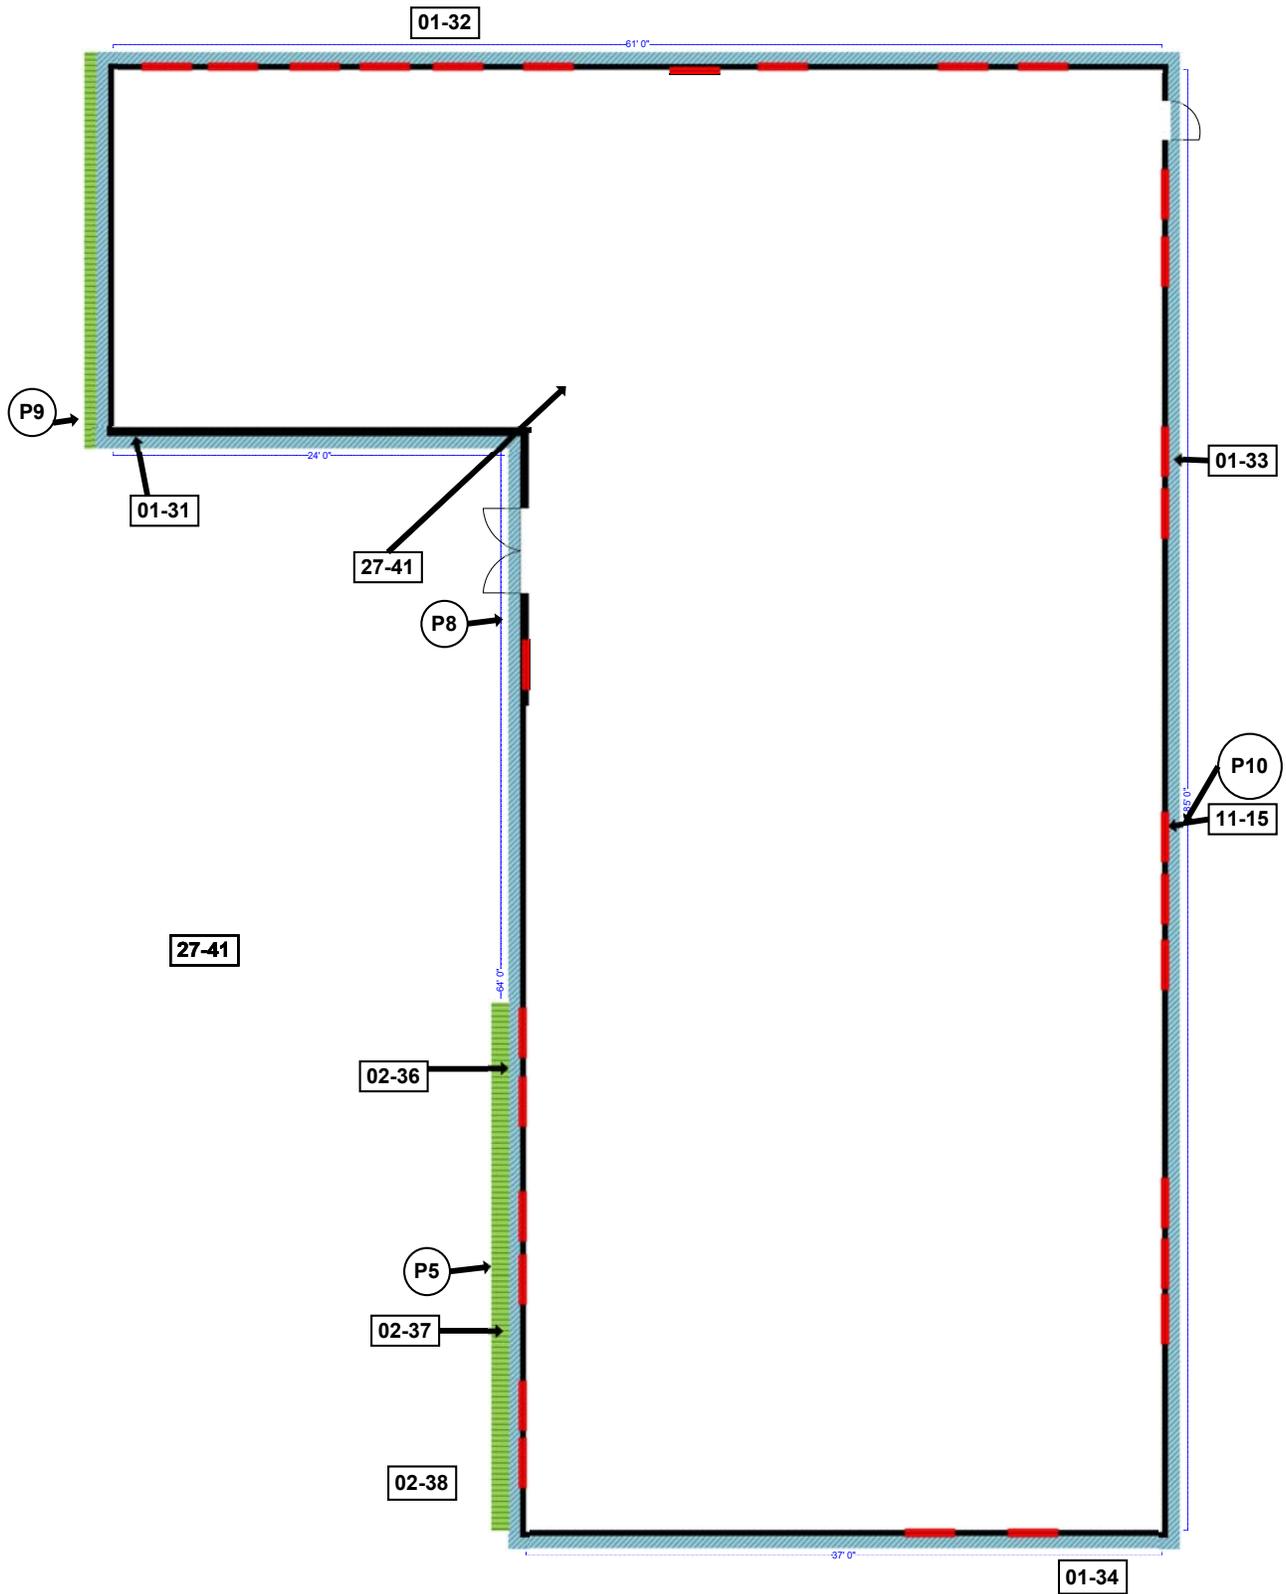
Exterior Sample Location Map  
 395 Amador Street  
 Vallejo, Ca

Stucco - Gray Stucco: <1 CH, Yellow Skim Coat: 2% CH
-

Exterior Rock: <1% CH, <0.25% CH by Point count:
-

Window Putty: <1% CH

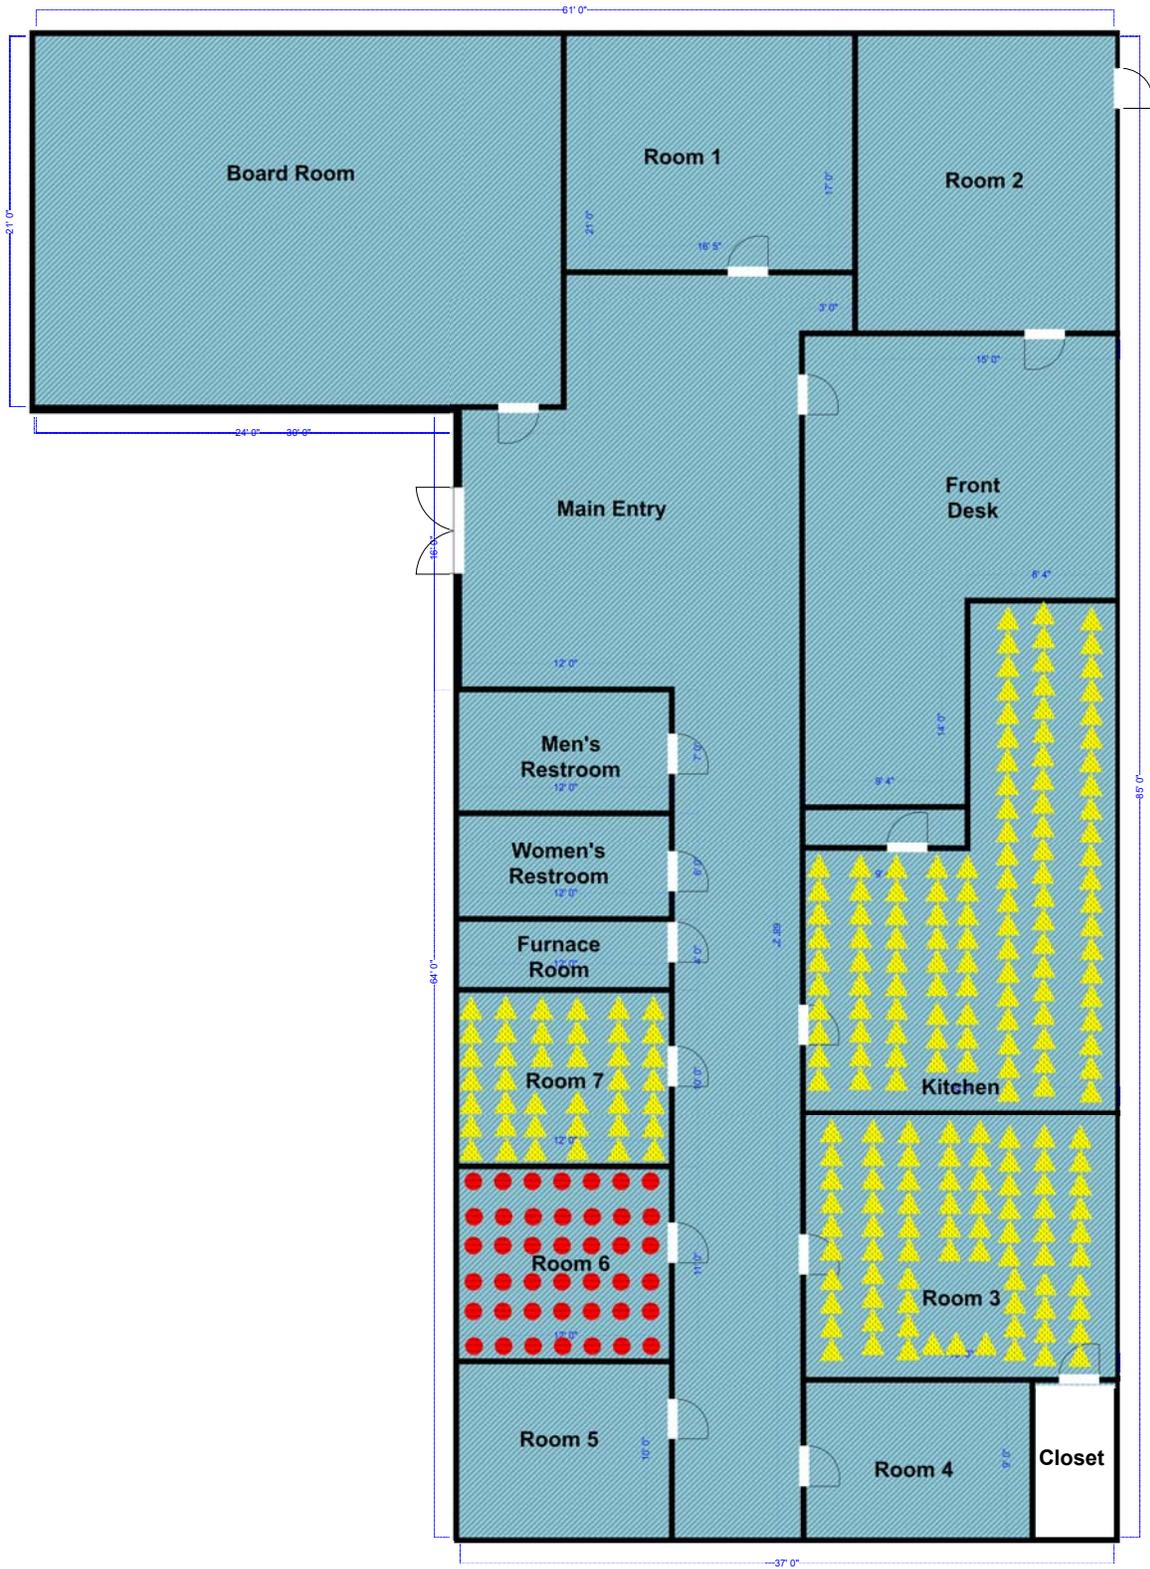
Flooring Sample Location Map  
 395 Amador Street  
 Vallejo, Ca

9x9 VFT / Mastic Under Carpet / Plywood - VFT = 8% CH / Mastic (Black) = 10% CH
-

12x12 White VFT / Mastic Over 9x9 VFT / Mastic - VFT = 8% CH / Mastic (Black) = 10% CH
-

9x9 VFT / Mastic (Exposed) - VFT = 8% CH / Mastic (Black) = 10% CH
