FIELD OBSERVATION REPORT A

PROJECT: Dan Foley Park, Vallejo; Synthetic Field Resurfacing

Lloyd Project No.
21-180

Site Visit Date & Time: Wednesday August 3, 2022, 8am

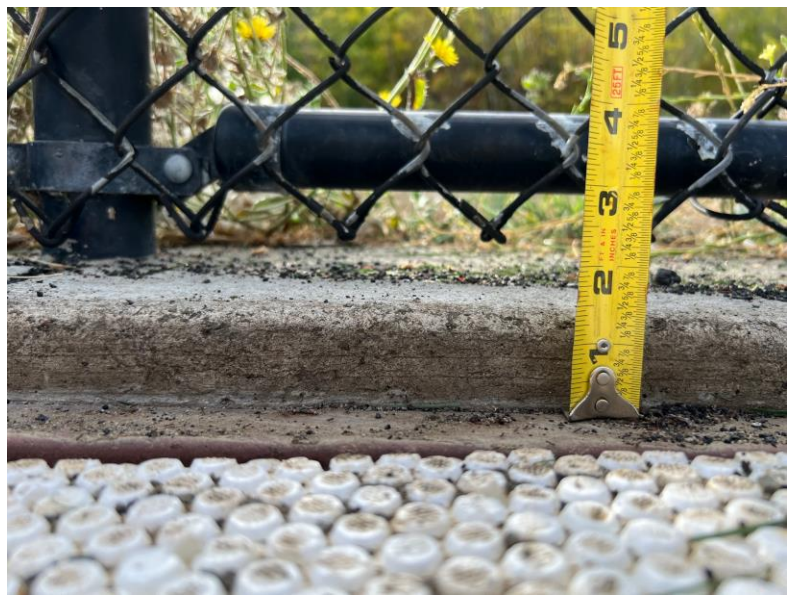
Photo #15 – Close-up

12. The perimeter nailer made of plastic/synthetic lumber was in serviceable condition and well anchored to the concrete perimeter band.

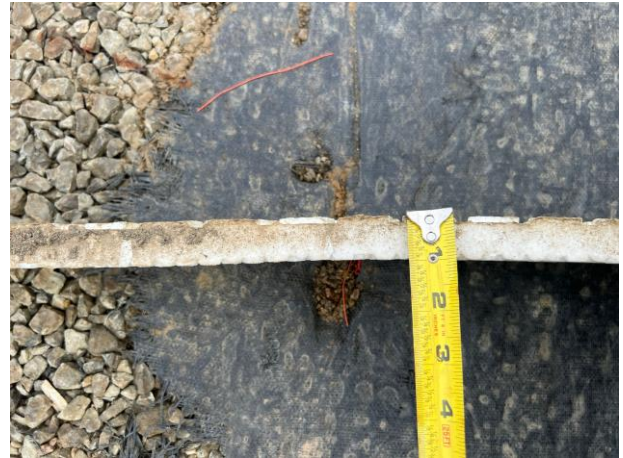
Photo #15 – Close-up

13. The underlayment is in fair condition and should withstand a resurfacing with only minor patch and repair after demolition of the turf. The product typical has a 20 - 25 year warranty.
